WESTRAC WA SOS Lab - 128 Great Eastern Highway (next to Institute)

ENGINE

T08P-54288-1415

EQUIP NUM: CCP39

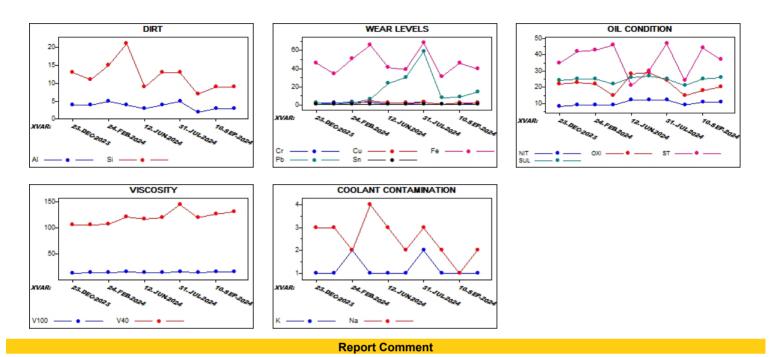
CONDITION-CONTAMINATION							
		09-Oct-24	10-Sep-24	08-Aug-24	31-Jul-24			
OIL CONDITION								
ST	Soot	37	44	24	47			
OXI	Oxidation	20	18	15	24			
SUL	Sulfur Products	26	25	21	25			
NIT	Nitration	11	11	9	12			
VISCOSITY (Centistokes)								
V100	Viscosity at 100 C	16.52	15.69	15.04	16.55			
VISCOSITY (Centistokes)								
V40	Viscosity at 40 C	130.9	126.7	120.1	144.1			
CRAC	KLE TEST							
W	Water	N	N	N	N			
FUEL								
F	Fuel	N						
OIL CLEANLINESS								
		09-Oct-24	10-Sep-24	08-Aug-24	31-Jul-24			
PQI		_		_				
PQI	PQ Index	9	10	2	13
